**THE EFFECT OF DISSOLVED OZONE ON THE CORROSION BEHAVIOR
OF MONEL 400, MONEL K-500, CDA 706, AND CDA 715 IN
SEAWATER**

J.H. Stevens and D.J. Duquette
Rensselaer Polytechnic Institute
Troy, New York 12180

October 1998

Report No. 5 to the Office of Naval Research
Contract No. N00014-94-1-0093

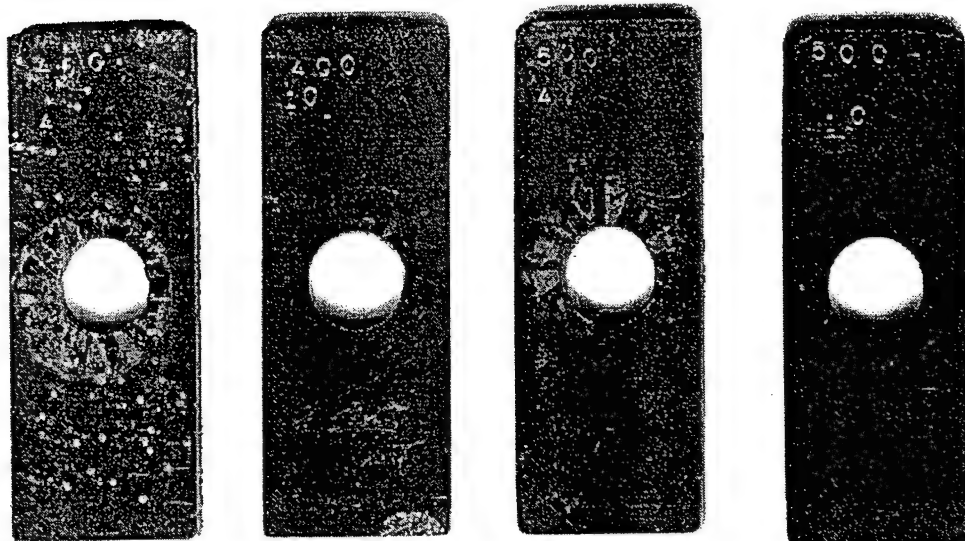
Figure 29. Crevice corrosion results after 60 days of exposure. From left to right: Monel 400 ozonated, Monel 400 aerated, Monel K-500 ozonated, and Monel K-500 aerated.

The crevice corrosion behavior of the Monel alloys follows the same trend as the general corrosion behavior. Localized attack was more severe on the Monel 400 alloy compared to the Monel K-500 alloy in ozonated seawater after thirty days. The Monel 400 alloy shows a green over black corrosion product predominantly adjacent to the tight crevice areas. The areas within the tight crevices show little attack with only some signs of pitting. The Monel K-500 alloy shows less corrosion product in these same areas. As time increased the attack became more severe in each alloy and environment. A greater amount of black corrosion product was seen at the mouths of the corroded regions (between the tight crevices). Pits in the tight crevices did not increase in number but became broader and deeper with time.

Figures 29 and 30 show sixty day crevice results of the alloys investigated in this study in aerated and ozonated seawater.

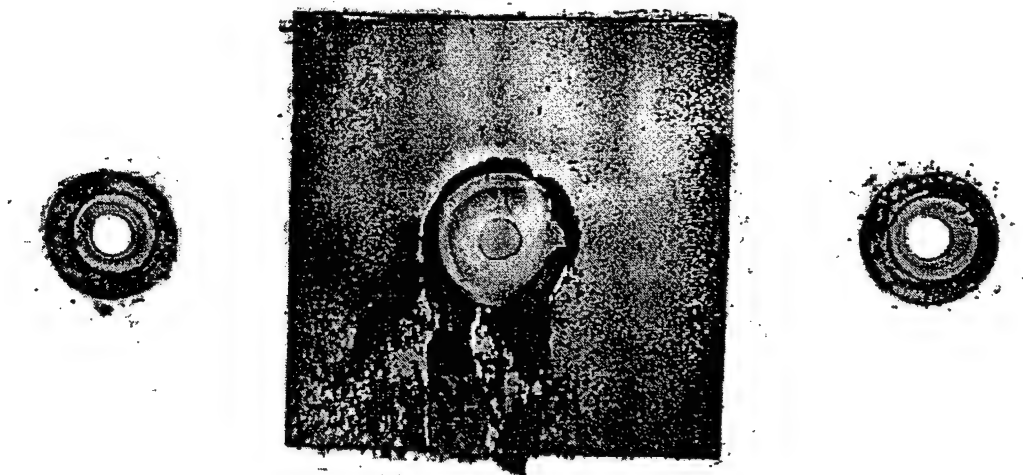
Figure 41. Appearance of Monel 400 alloy unassembled after sixty days of exposure to ozonated seawater in Wrightsville Beach, N.C.

Examples of the appearance of the Monel 400 samples after sixty days of exposure are shown in figures 41 through 48. The sample exposed to ozonated seawater was covered with a brown film with areas of a black powdery corrosion product associated with pitting. This corrosion product was concentrated around the mouths of both the nonmetal-metal and metal-metal crevices. This voluminous corrosion product also ran down the sample as can be seen below. A green corrosion product was intermixed with the large volumes of black corrosion product around the mouths of the crevices and running down the sample from the crevice. The areas within the crevice were unaffected by the exposure to ozonated seawater and show no corrosion.

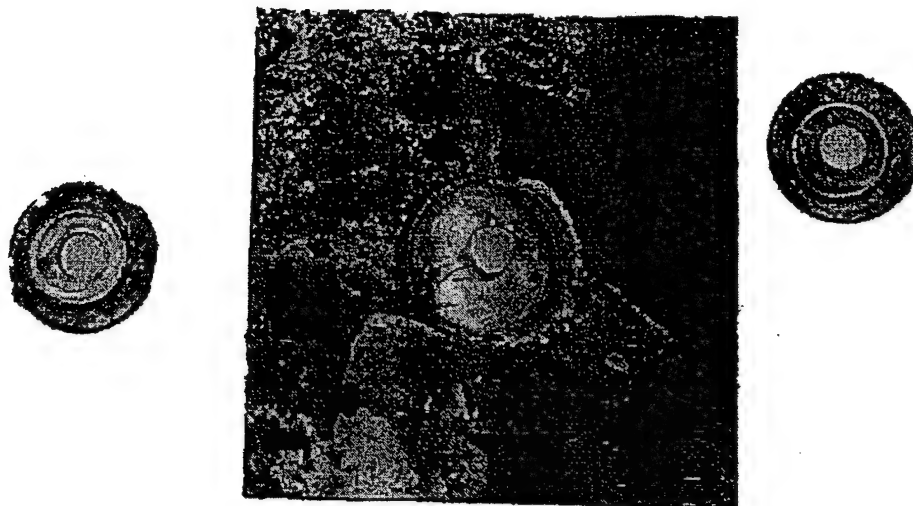
Figure 55. CDA 706 crevice assembly exposed to ozonated seawater sixty days at Wrightsville Beach, N.C. and unassembled.

The CDA 706 alloy (90Cu/10Ni) showed largely general corrosion over the surface. The corrosion products had a layered appearance. The top most layer was a green corrosion product while under that a sparse black corrosion product was formed. Further below a thin brown corrosion product covered most of the sample, much like the brown film seen on the Monel alloys. Other areas show a more copper colored appearance with spots of a red corrosion product or film formed underneath.

Localized corrosion occurred at the mouth of the crevice, as seen in the Monel alloys, in some cases traveling down the sample slightly. Localized attack at the mouth of the crevice was not as severe or deep as that seen in the Monel alloys. Around the mouths of the crevices a red corrosion product or film was found, sometimes in conjunction with the green and brown/black corrosion product. Within the crevice some pitting was experienced. However, the pitting was shallow and not of consequence when compared with attack outside the mouth of the crevice. An example of the CDA 706 alloy after removal from ozonated seawater and disassembly is presented in figure 55.

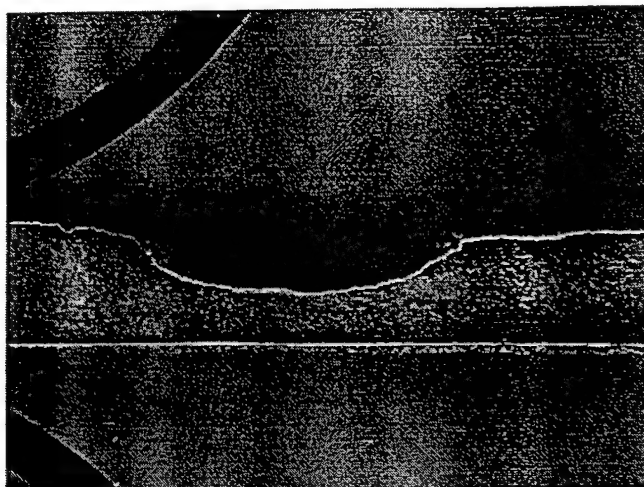
That plate showing extensive attack was cross-sectioned, the results is shown in the figure 71. Up to half of the plate thickness was corroded away during sixty days of exposure to ozonated seawater, the corresponding washer was also severely attacked. Otherwise, only a small amount of attack was observed in ozonated seawater at the mouth of the crevice.

Figure 71. Cross section of Alloy 625 plate exposed for sixty days to ozonated seawater at Wrightsville Beach, N.C.. Sample is shown after disassembly and cleaning.

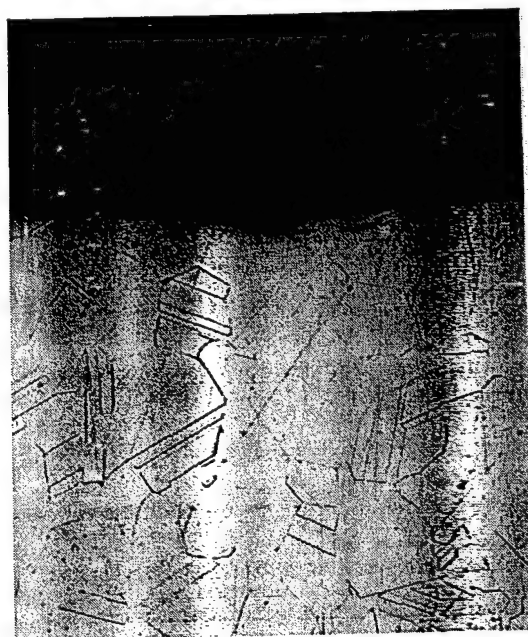
A cross section is also shown of a washer section in order to exhibit the extent of attack seen in these alloys after exposure to ozonated seawater. The attack occurred at the mouth of the crevice, immediately outside the crevice interface.

Figure 76. Cross-section of washer after sixty days of exposure to ozonated seawater. sample is shown after disassembly, cleaning, etching with 0.5g CrO_3 in 100ml HCl , and magnification of $126\times$.
